PVC PIPE

United Water Pennsylvania and the Susquehanna River Pipeline Rehabilitation and Sliplining Solution

by **Joan McConahy**
Marketing Communications Manager
Underground Solutions, Inc.

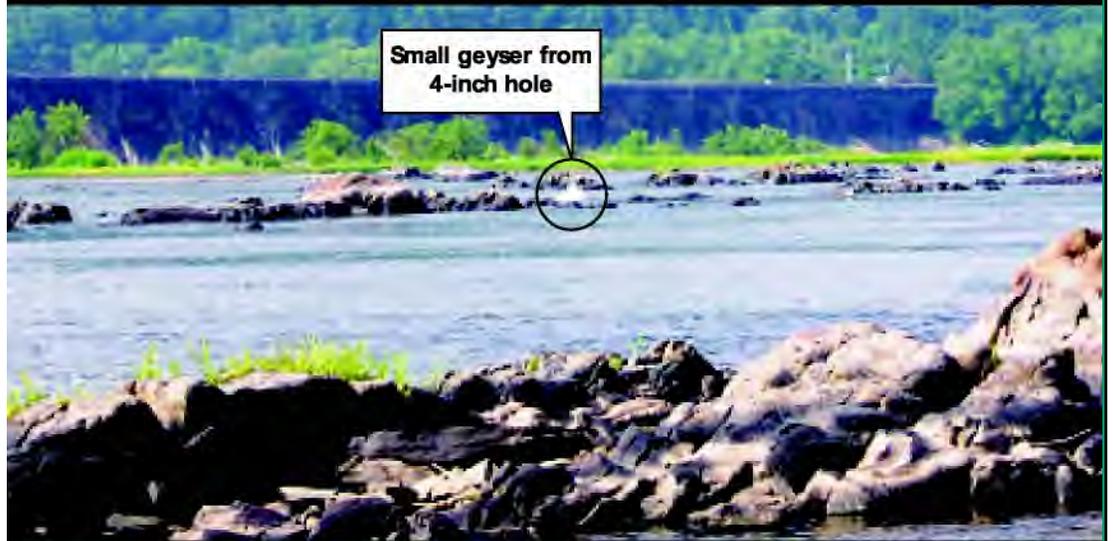
Figure 1: This small geyser appeared in the Susquehanna River in the Summer of 2005. A leak in a 16-inch cast iron line produced the geyser. It was under high pressure to help locate the leak.

somewhere along the 16-inch cast iron line, locating the problem became a top priority. For months they attempted to locate the problem and noticed during the summer of 2005 that the losses had increased. Through a comprehensive series of tests, they located the main site of the leak, and with the water under high pressure, a small geyser in the middle of the river showed the exact location of the hole where the water loss was occurring. (See Figure 1.) A primary concern was that after its long service, there could be many other weakened areas along the length of the pipe that was on the floor of the river. This raised many questions. How many other smaller holes were there along the line? How long would it be until other weakened areas would become holes and add to the loss of water? It was determined that as a result of the leak hundreds of gallons of water per minute were being lost from the system.

Inspection determined that the hole in the pipe was due to abrasion and erosion of the pipe's exterior from sand, dirt, rocks, ice and the swiftly flowing water. Consequently, fixing this particular hole in the pipe would not solve United Water's problem. It was recognized that the combined effects that

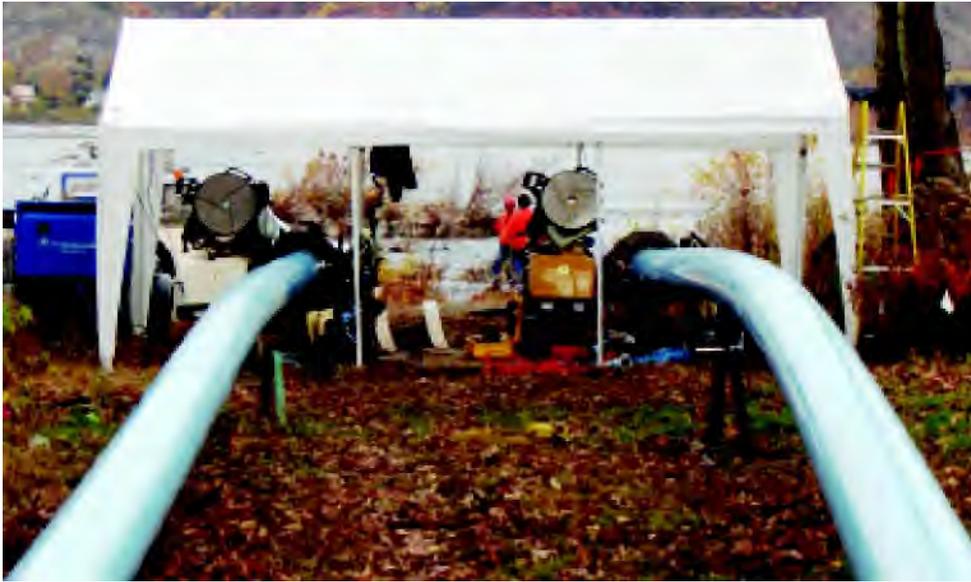
Figure 2: Two fusion machines were used to increase production.

Our company's trained fusion technicians butt fused the joints using two McElroy TracStar 500 machines. Data loggers were used with each machine to record the real-time pressure, duration, and initial temperature of each joint. Due to difficult pipe handling and site conditions along the bank of the river, each joint took approximately 45 minutes to fuse and about a half hour to set-up. (See Figure 2.)

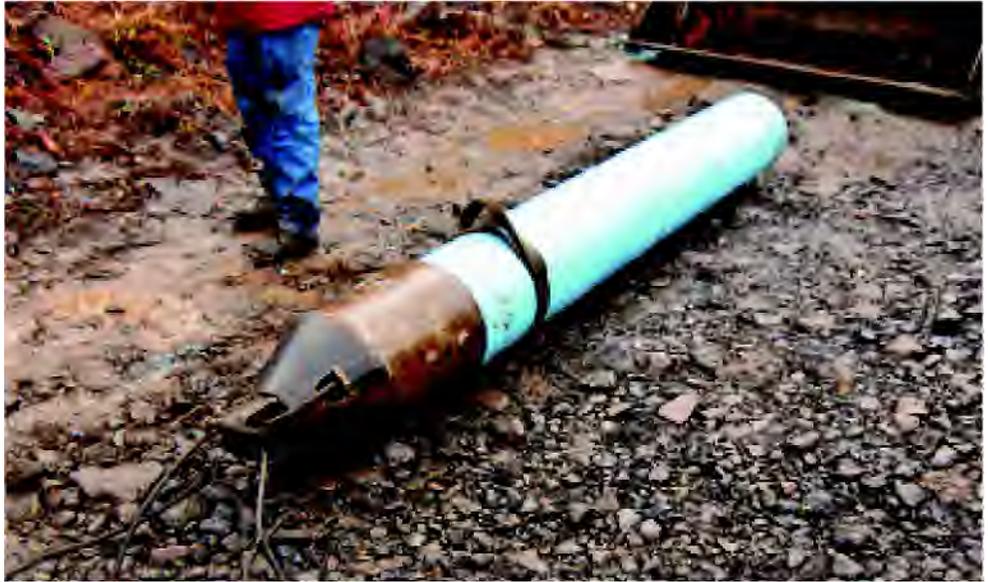
Figure 3: By pulling this "prover" through the host pipe, it demonstrated that both the pipe and pulling head could negotiate the entire run.

A prover (See Figure 3.) was sent through the host pipe after cleaning. This" proved" that the pipe and pulling head could pass through the newly cleaned host pipe interior and accommodate any alignment changes. The prover passed through the 3,515 LF of cast iron host pipe and

emerged from the pipe outlet on the eastern bank of the river without difficulty.

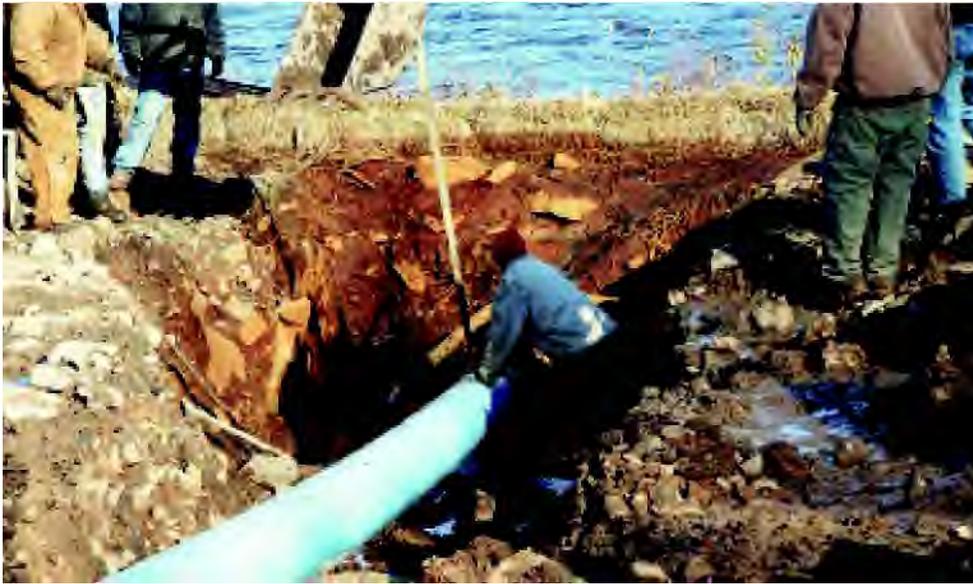
Figure 4: 12-inch product being inserted into a 16-inch iron main.

The diameter selected for the project was 12-inches, and the Pressure Class was 150 psi. The sliplining was to begin at the west bank of the river and end at the east bank. This was the longest single pull of PVC in the world to date.
