**North American Society for Trenchless Technology (NASTT)  
NASTT's 2017 No-Dig Show**

**MM-T4-02**

**American Canyon Rehabilitates Aging Steel Transmission Line by  
Pipe Bursting**

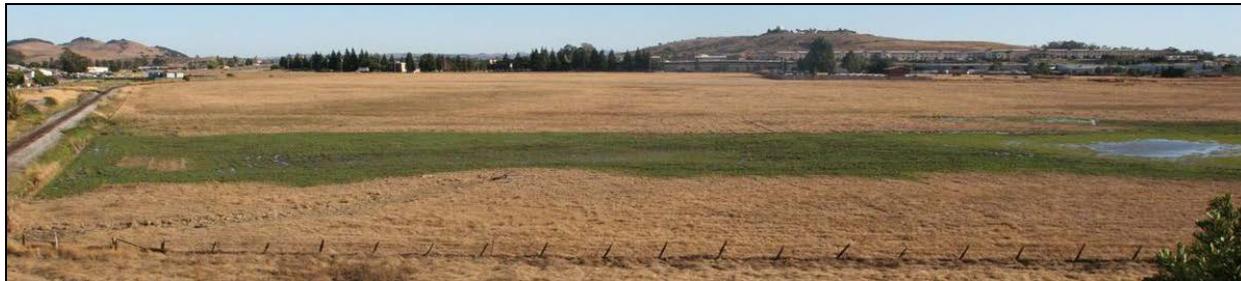
or 10% of the city's total water demand. The 70-year-old transmission main was located along a roadside ditch with a few swales that detoured into vacant fields. The leaks along the line would fill these ditches with potable water that would then migrate through the swales to open fields, resulting in bright patches of green grass scattered along the alignment in the midst of the drought (see Figure 2).

Figure 2. Wet patch in a typically dry cattle field, a result of run-off from the leaking water main.

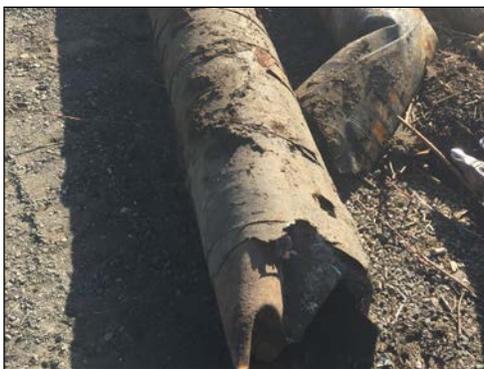
Figure 3. Existing 14-inch steel transmission main installed in the 1940s.

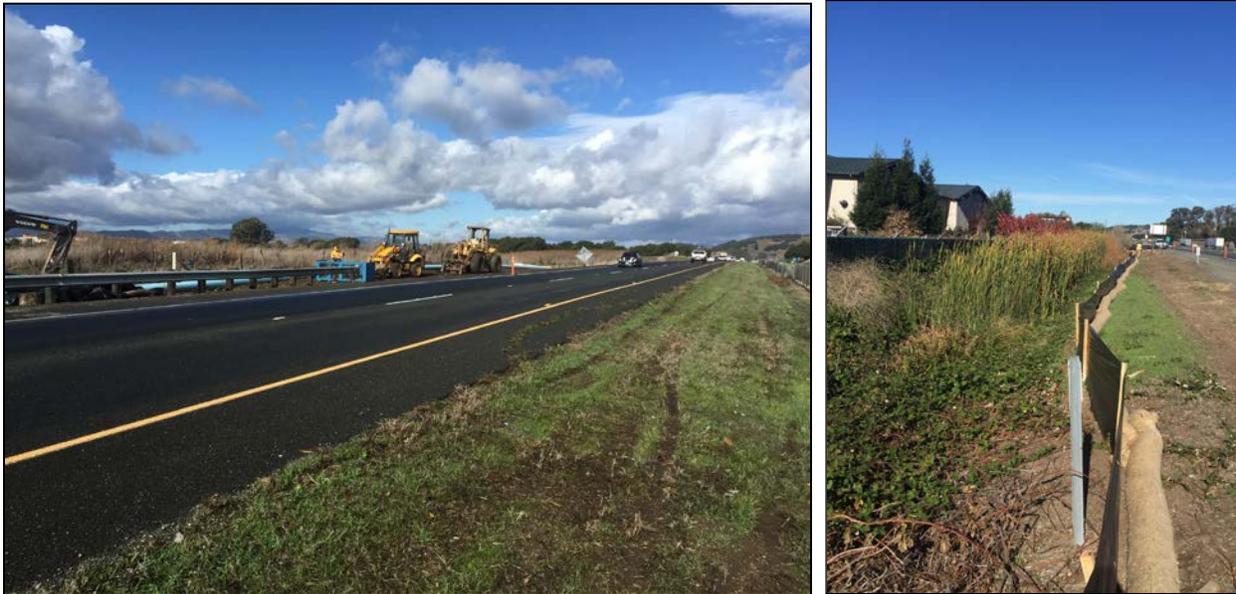
The existing 14-inch steel pipe laid at the bottom of the roadside ditch along CSR 29 with a minimum cover of three feet. There was only 5 to 10 feet from the ditch to the southbound lane of the highway, without any barriers between them. CSR 29 consists of two southbound and two northbound lanes with a posted speed limit of 65 miles per hour and approximately 50,000 vehicles travelling the route daily (see Figure 4). Other traits of the alignment included a creek crossing and ditch “habitats” that had formed in the over-saturated land above the leaking water line (see Figure 4). A mixture of potable chlorinated water from the steel line and storm water run-off into the ditch developed into a habitat with green vegetation, tules (typically found in marshlands), and a potential for red-legged frogs. The design needed to consider the impact of construction on highway traffic and the environment. A single lane closure would severely hinder residents’ daily commute and damage to these habitats and their wildlife would go against the city’s preservation efforts.

Figure 4. Environment near existing 14-inch steel pipe [southbound lanes of CSR 29 (left); ditch “habitat” (right)].

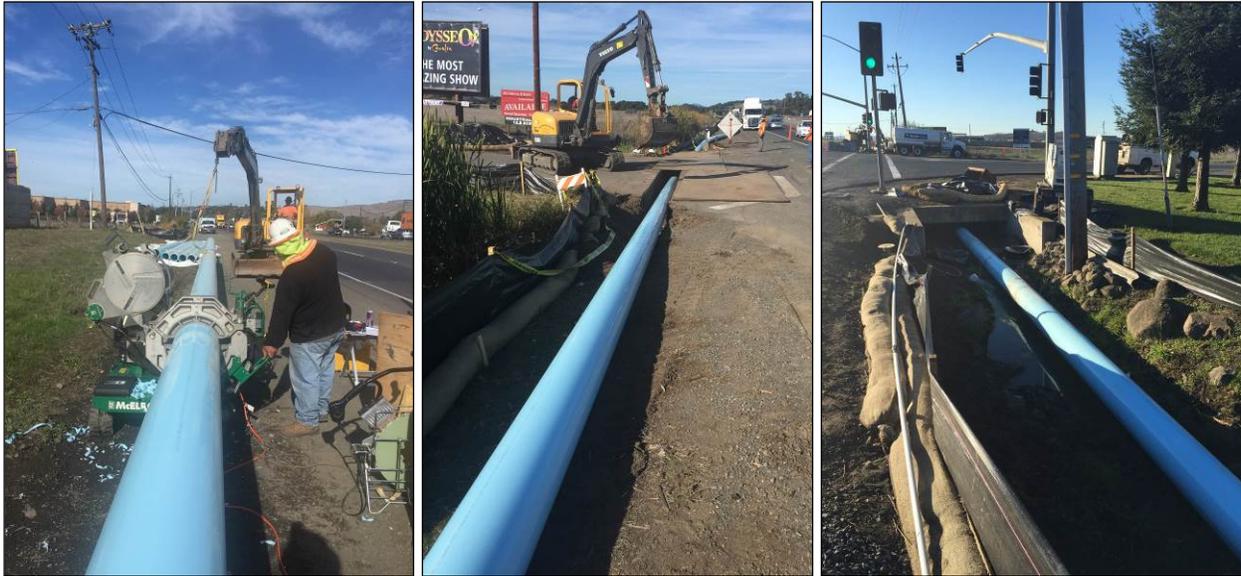
Fusion of 12-inch FPVCP began on November 4, 2015 for the first pipe burst run of the project. Fusion equipment was set up along the western shoulder of CSR 29 where fused pipe could be strung out to the total length needed for each pipe burst run (see Figure 7). Traffic control was minimal since all lanes of the highway were kept open for the duration of the project. However, several side streets and businesses were accessed off CSR 29. Access to the side streets had to be maintained at all times and driveways needed to be open to the public at least during business hours. The long pipe strings would occasionally cross one of these paths and, instead of attempting a tricky aerial

layout or blocking access entirely, shallow trenches were excavated across the road and then covered with steel plates to maintain vehicular access and allow constant access for the pipe to cross (see Figure 7). At some crossings, the contractor was able to use existing drainage culverts to pull a fused pipe length under a road (see Figure 7). Both crossing methods allowed the pipe to be fused to the full length required for each run without need of intermediate fusion joints.

Figure 7. Pipe fusion and layout [fusion (left); layout under road (center); layout through culvert (right)].

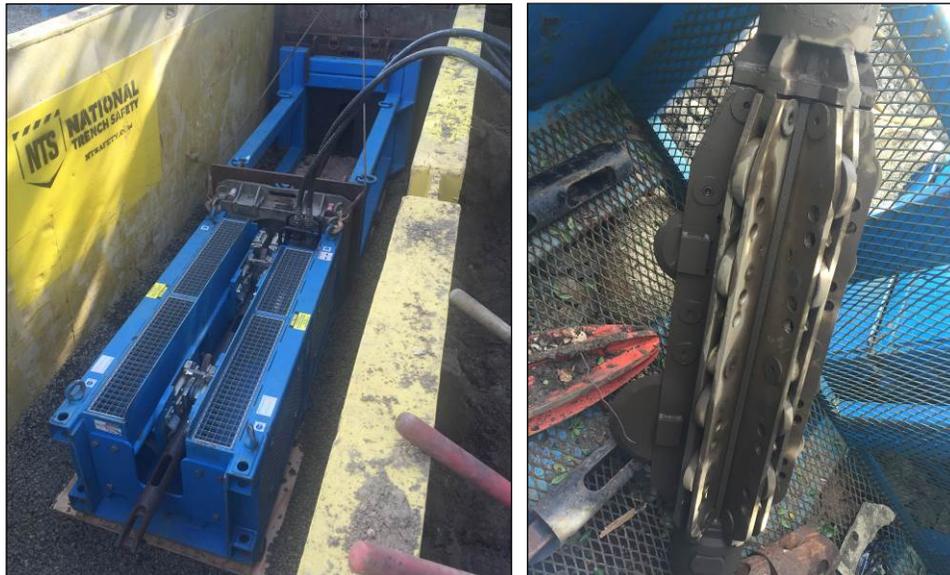
The pipe bursting equipment and pits were set up away from any driveways or intersections to avoid conflict. JMB used a static pipe burst unit from TT Technologies to install each of the pipe burst runs (see Figure 8). The unit used “Quickloc” bursting rods that allowed the contractor to add or remove rods much faster than standard threaded rods and a rolling blade cutting rod (see Figure 8) to slice the steel before it met the expander head.

Figure 8. Static pipe burst equipment [static pipe burst unit in exit pit (left); roller cutters (right)].

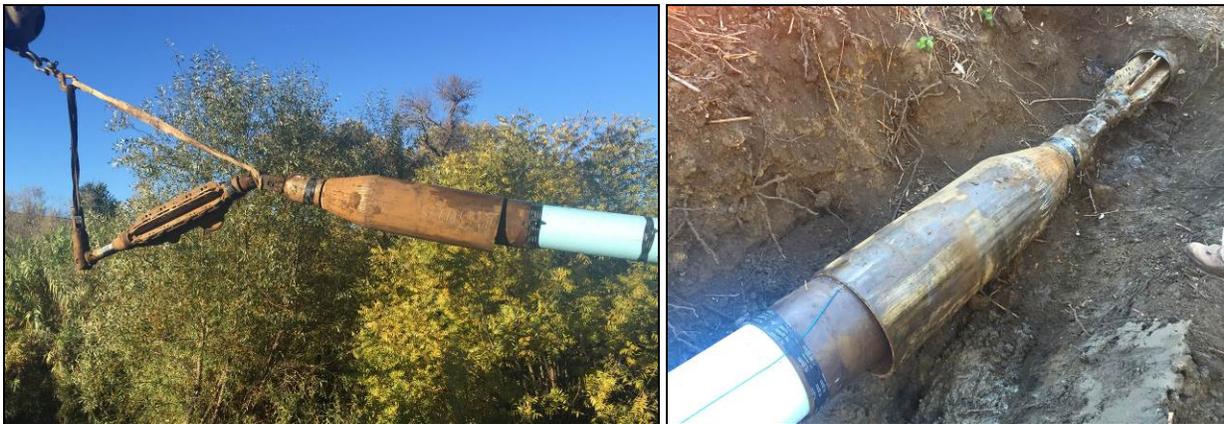
The number of pipe burst lengths was reduced to six. For each run, JMB set up the bursting unit in the exit pit and then fed the bursting rods through the existing steel line to the entrance pit. On the entrance pit side, a roller cutter and expander head were attached to the new 12-inch pipe and connected to the bursting rods (see Figure 9). At that point the assembly was pulled back through the existing line (see Figure 9), cutting and bursting open the 14-inch steel and pulling the 12-inch FPVCP into place behind it all the way to the exit pit (see Figure 10). Because the existing pipe alignment was under the drainage ditch, the pipe strings laid out through the drainage culverts and along the shoulder of the freeway could be pulled into the entrance pit with little to no adjustments. For four of the six runs, pulling the new pipe string into place did not obstruct access to any facilities, which allowed them to be installed during the day. The other two runs, however, would cross and block off several driveways during installation. These could not be installed during business hours, requiring night work. The pipe was strung elsewhere prior to installation and then pulled into place when the run was ready for pull back.

Figure 9. Installation from entrance pit [cutter and expander assembly (left); initial pull into existing steel (right)].

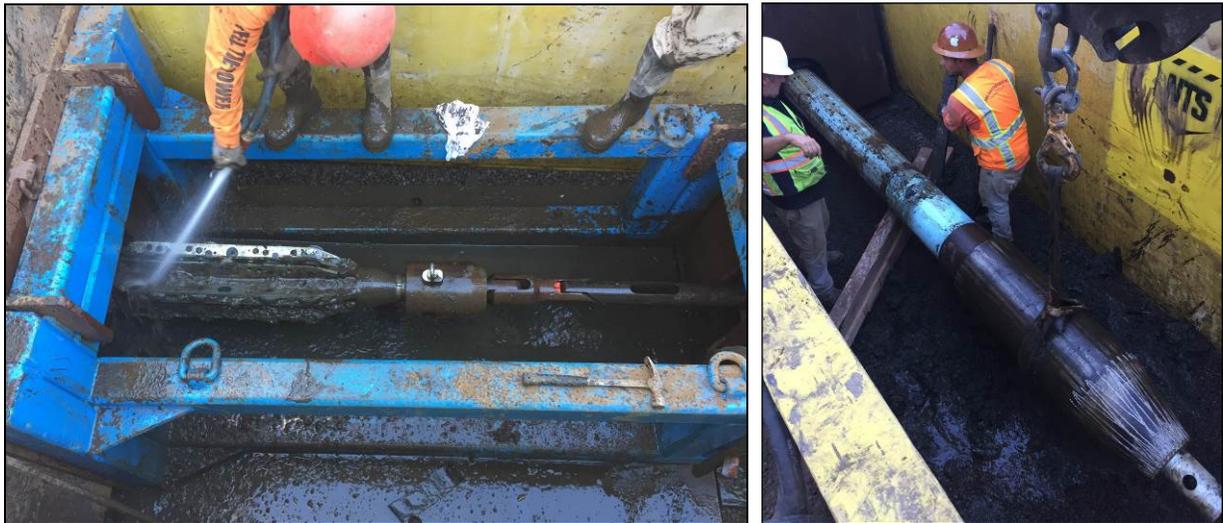
Figure 10. Installation from exit pit [roller cutter pulled through (left); pipe pulled completely through (right)].
